POINT BONITA LIGHTHOUSE BRIDGE – RG 2858

GOLDEN GATE NATIONAL RECREATION AREA, CALIFORNIA

FHWA PROJECT – CA NPS GOGA 433(1)

STRUCTURE SELECTION REPORT

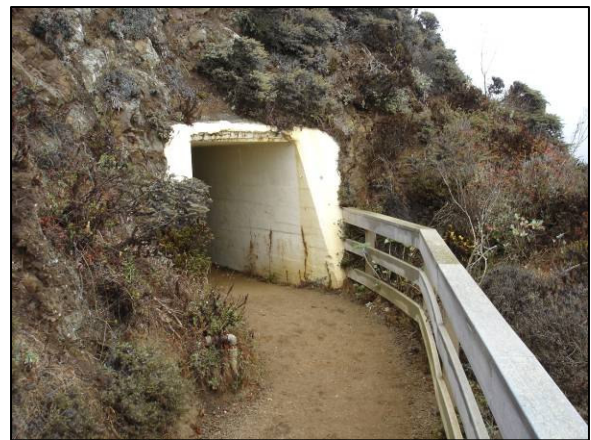
West tunnel portal and narrow trail.

locking steel door at the east tunnel portal provides an opening of about 6 feet tall by 4 feet wide. The arched tunnel is only slightly larger than the doorway: about 6 feet, 6 inches high, 4 feet wide at the top, and 6 feet wide at the bottom. West of the tunnel, the trail is even narrower, with sharp curves, and is further limited by two newer pedestrian bridges with a clear width of about 4 feet, 6 inches. The east end of the suspension bridge could serve as a secondary construction staging area with a maximum area available of about 3,000 square feet.

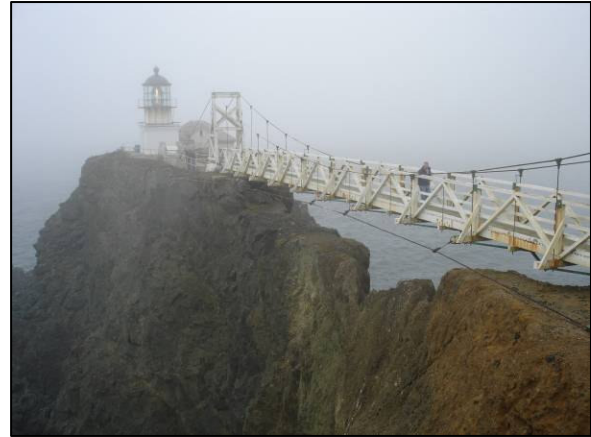
Note showing steep rocky cliffs and narrow isthmus under bridge.

Once the bridge is removed, access to the far (west) side is obviously more difficult. However, the bridge doesn't span over water but over a depressed, narrow, knife edge isthmus, with near vertical cliffs on either side. A protected path of ladders and walkways could be constructed, down - across the isthmus - and up the other side. Workers could use this walkway to get back and forth but equipment would need to be brought to the west side prior to removal of the existing bridge or brought in by helicopter.

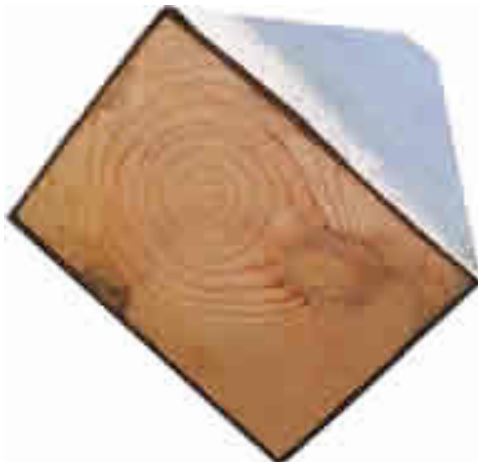
Cross section of 21Poly coated Wood.

Unfortunately, there are only a limited number of manufacturers that produce plastic coated wood. 21POLY, one of the more common coating systems, was developed by the Northstar company. 21POLY uses a patented spray process that bonds a protective polymer layer to pressure treated wood. According to the company's literature, the system has been used by the U.S. Army Corps of Engineers, the National Park Service, the U.S. Fish & Wildlife Service, and the San Francisco Harbor and Port Authority. It is applied by a licensed applicant, usually the same company that treats the wood. Some applicants have mobile applicators that can apply the product on site.

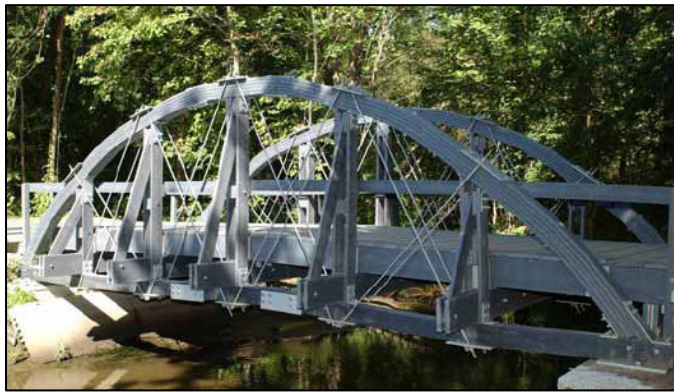
Example vehicular bridge made from structural grade plastic lumber.

Another option might be structural grade plastic lumber, which is plastic lumber that's been reinforced with other materials, such as fiberglass and polystyrene. Structural grade plastic lumber is a high-performance timber product that is extremely suitable for marine construction. It has exceptional resistance to marine borers, salt spray, fungi, and other environmental stresses. It does not absorb moisture, so it can't rot, splinter, or crack. Structural plastic lumber is produced in a wide range of dimensional lumber and timber sizes. It

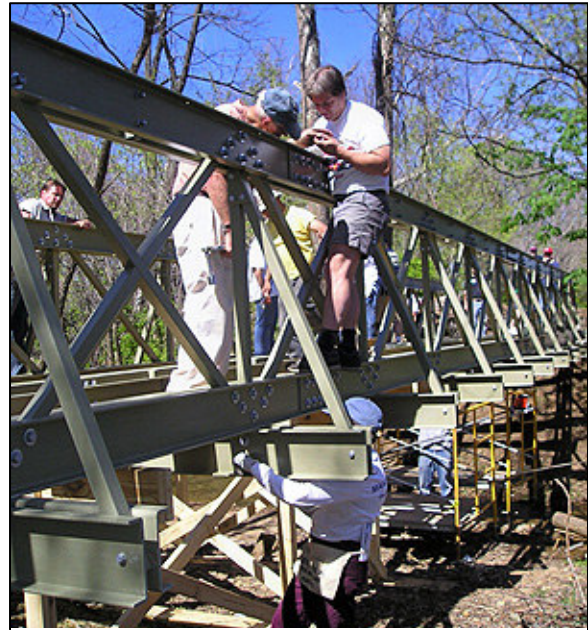
FRP pedestrian truss bridge being erected.

FRP shapes are significantly lighter than almost any other building material. As a result, the individual members can easily be carried by one or two people, making it easier to erect the bridge in a remote location like Point Bonita. Shapes made of FRP are also extremely durable in harsh environments. FRP is more flexible and designs are typically controlled by deflection rather than strength, and, under sustained loads, FRP shapes continue to deflect or creep. However, FRP is more easily damaged than other materials, and over-tightening of bolts can crack it. The material costs for FRP shapes are about the same as equivalent steel shapes and about twice as much as pressure treated wood.
